BUREAU OF YARDS AND DOCKS WASHINGTON D C

AEC-WT-91

Since protective construction is a problem common to civil as well as military installations, practical methods of design and analysis for blast loadings must be developed for use by structural engineers. The method of design and analysis used in Project 3.2 was developed for practical use by A. Amirikian, Consultant on Special Structures for the Bureau. The complete postshot analysis for two of the most important structures may be found in Chap. 7. The remaining structures will be analyzed as time permits.

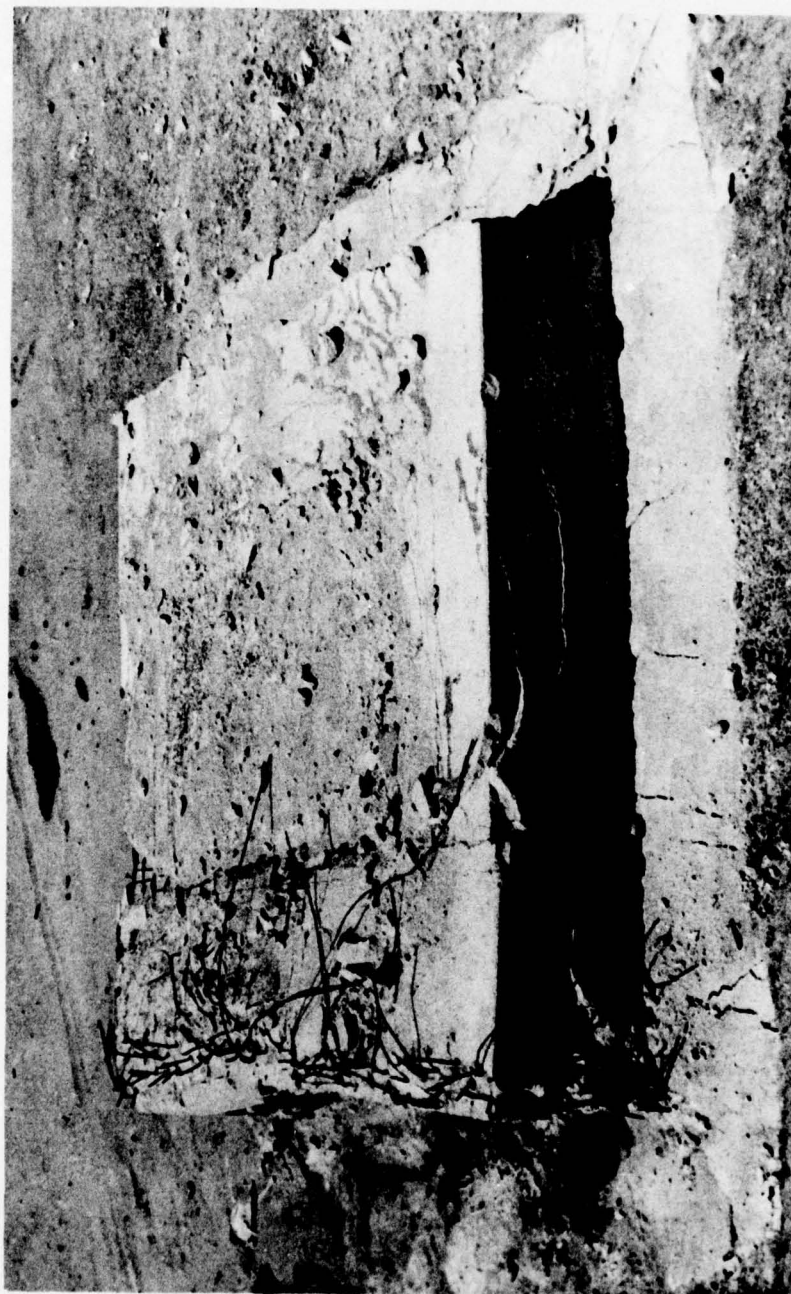
Fig. 6.13 Postshot Aerial View of Structure 3.2.1a

near the front edge of the roof, and a vertical displacement of 6 to 8 in. occurred. The anti-scour ramp and the earth in front of the structure were scoured away to the top of the footing mat, exposing the front support wall. This wall deflected severely in the center but retained its end connections. Only the roof was being tested (Fig. 6.13).

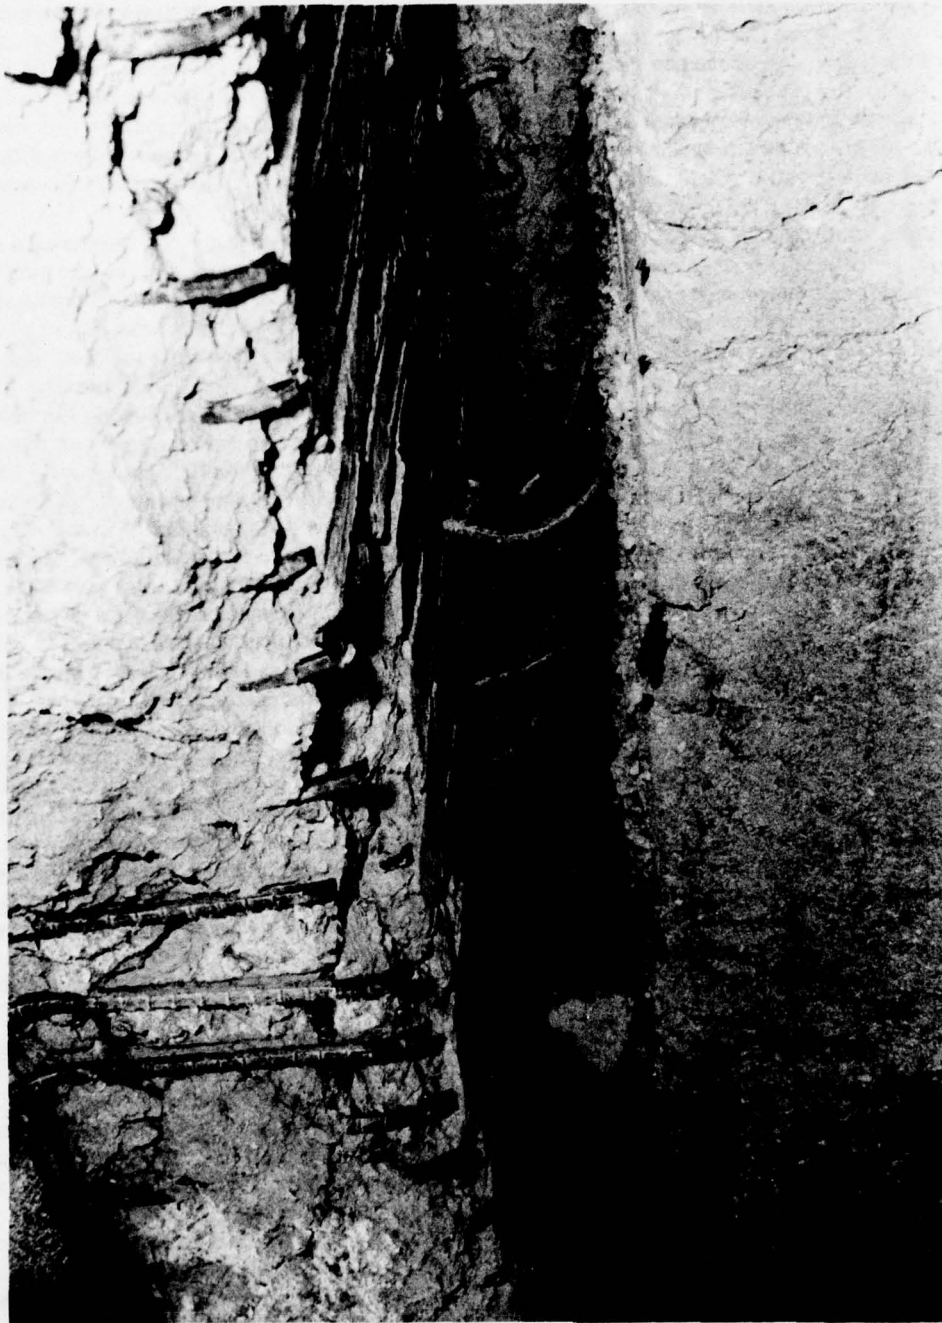
The vertical dowels connecting the slab to the front wall were sheared off by the wall movement, the steel failing mainly in shear. The ends of the broken dowels scratched the underside of the roof slab as the wall moved in (Fig. 6.16). The steel at the shear plane in the roof slab was badly bent but did not fail. This vertical truss steel was exposed on the top and bottom of the roof slab. The 5 per cent maximum roof deformation fell safely within the 10 per cent allowed before failure can be considered to have occurred.

Fig. 6.16 Undersurface of Top Slab Showing Dowel Scratches When Front Support Wall Is Deflected Inward

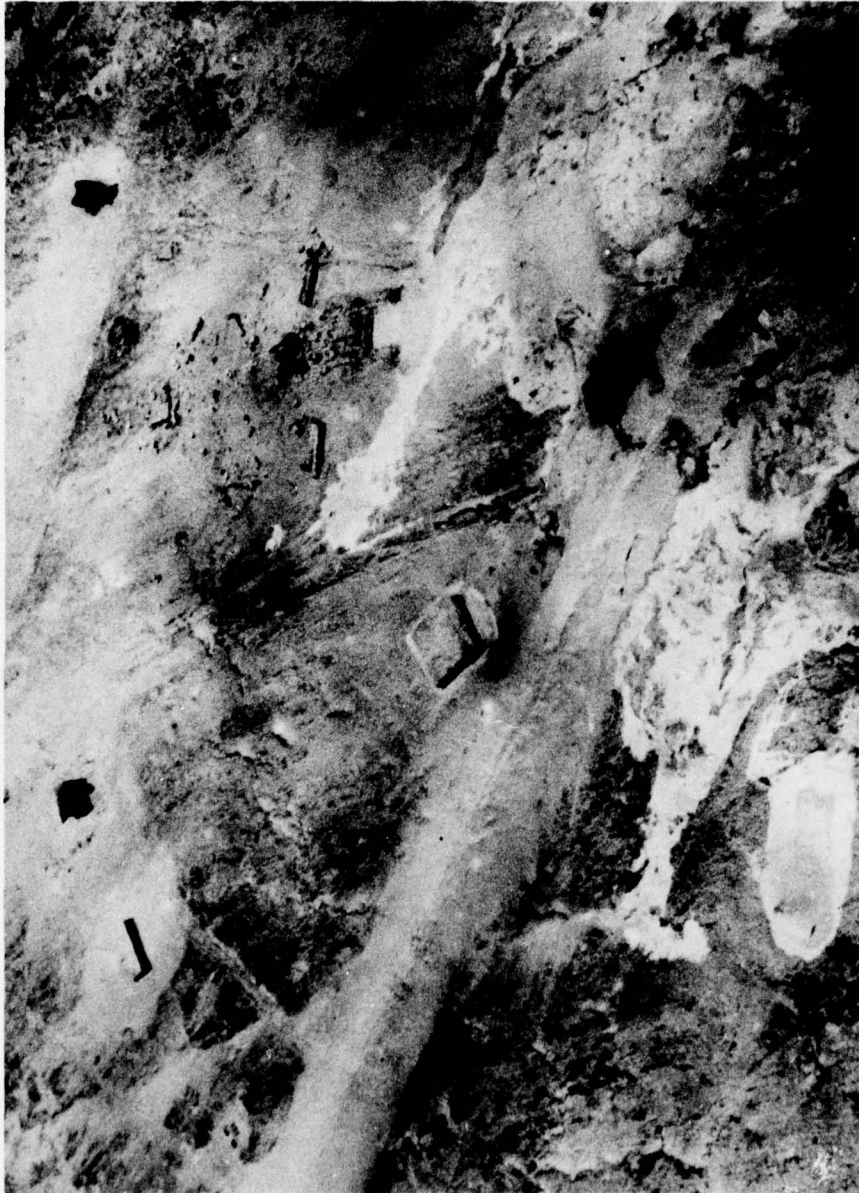
(a) *General Damage.* Structure 3.2.1b was completely demolished (Fig. 6.20). The roof section was torn loose from the foundation, broken up into pieces, and scattered over a radius of 200 ft beyond the building. The sides were blown out and slightly to the rear. The top slab was separated from the top layer of cells and moved approximately 150 ft to the rear, right side up, but badly cracked and spalled. The center and lower layers of cells were broken up badly and blown behind the structure. The front wall of the foundation was exposed by

Fig. 6.20 Postshot Aerial View of Structures 3.2.1b (Upper Right) and 3.2.1a (Center)

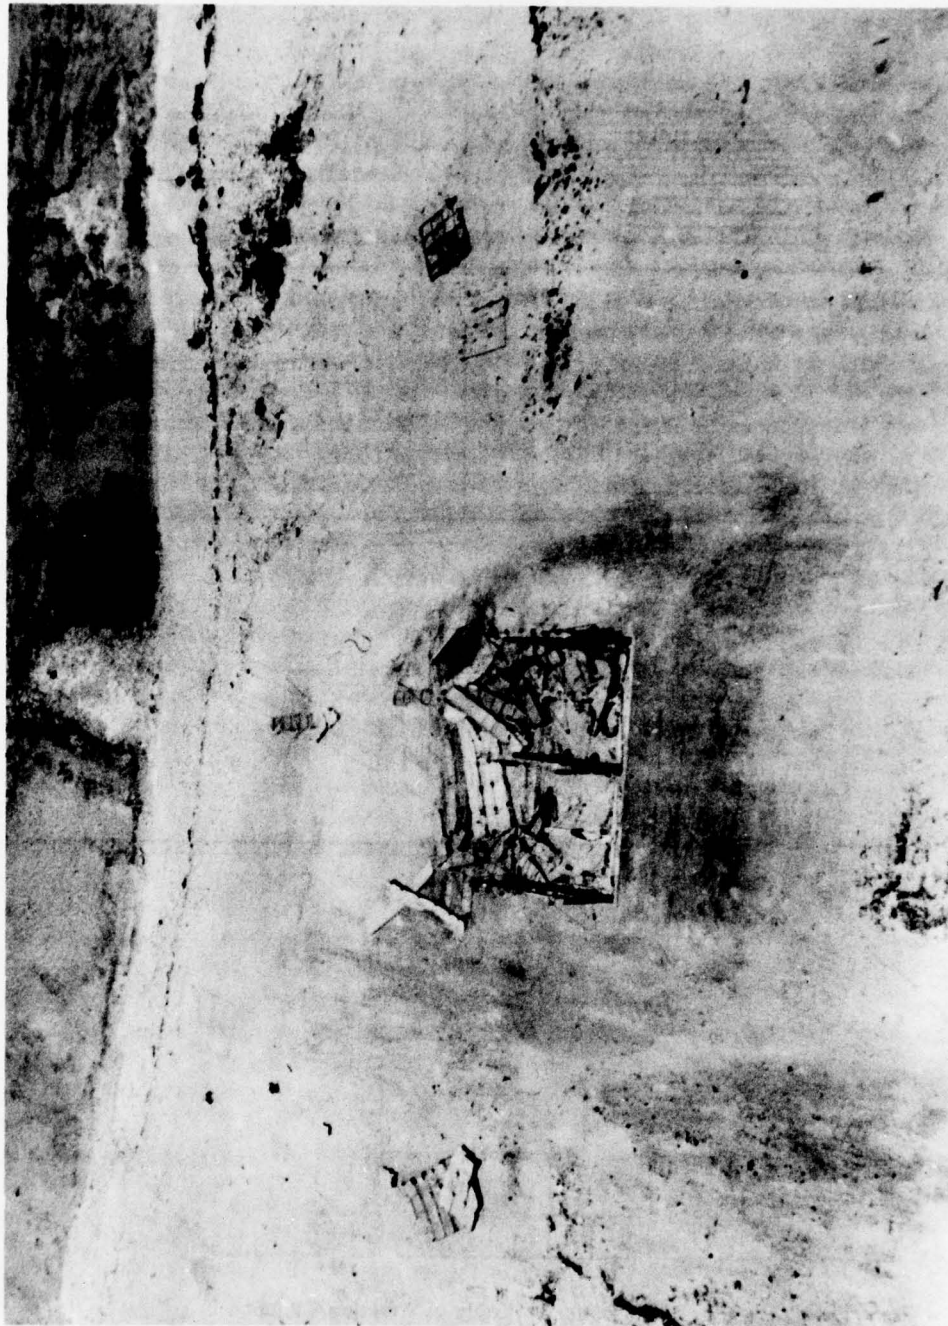
Fig. 6.26 Postshot Aerial View of Structure 3.2.2a

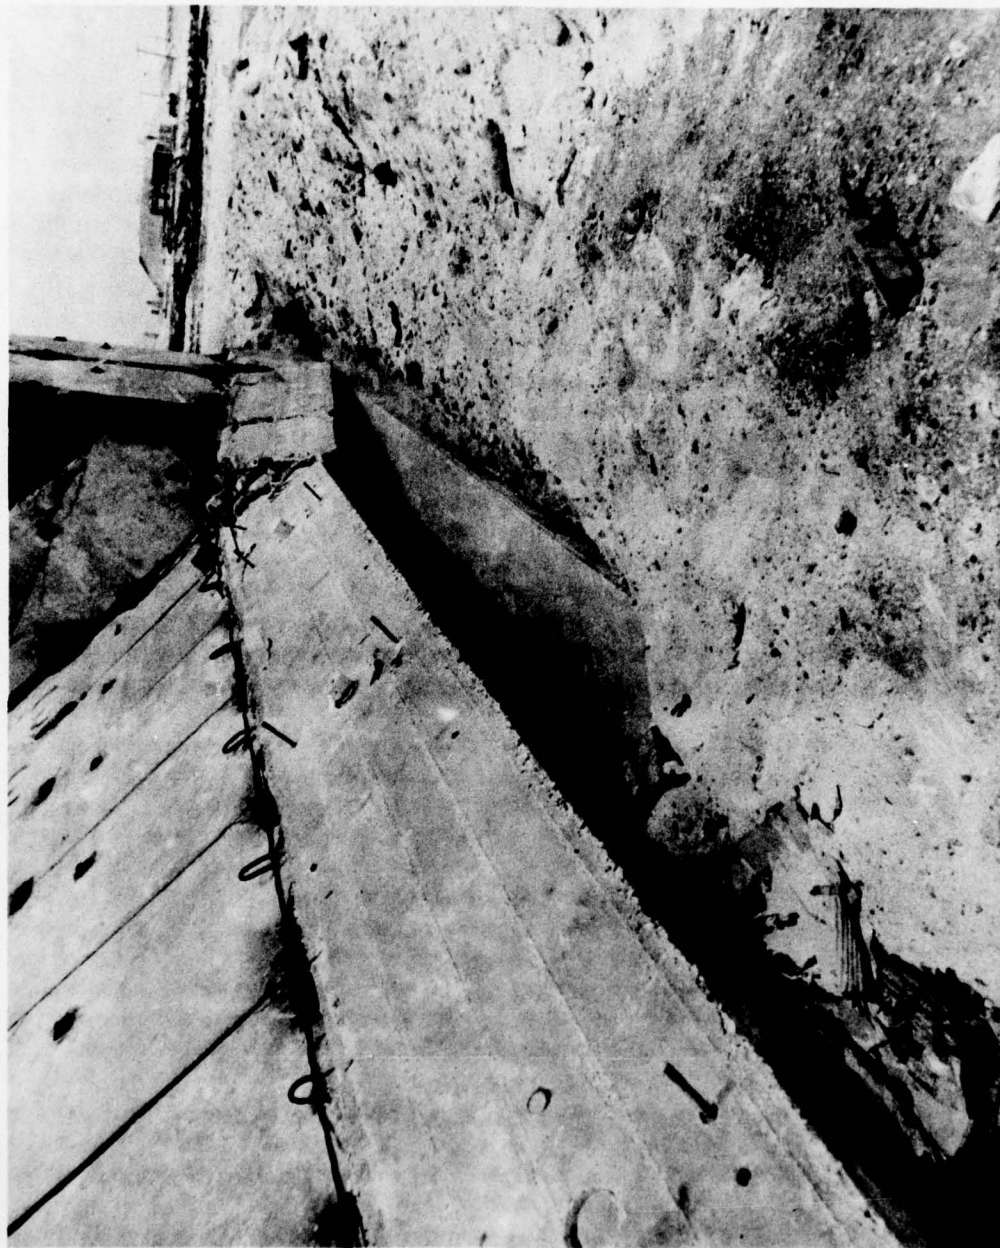
The front-wall panels were relatively undamaged except at the points of separation near the corners. Some inward deformation occurred within the individual panels. When the wall rotated, the footing supporting the panels rotated and was lifted with the wall since it had no restraint (Fig. 6.35). This uplift caused several breaks in the footing because the ends were an-

Fig. 6.35 Panel Footing in Uplifted Position, Structure 3.2.2b

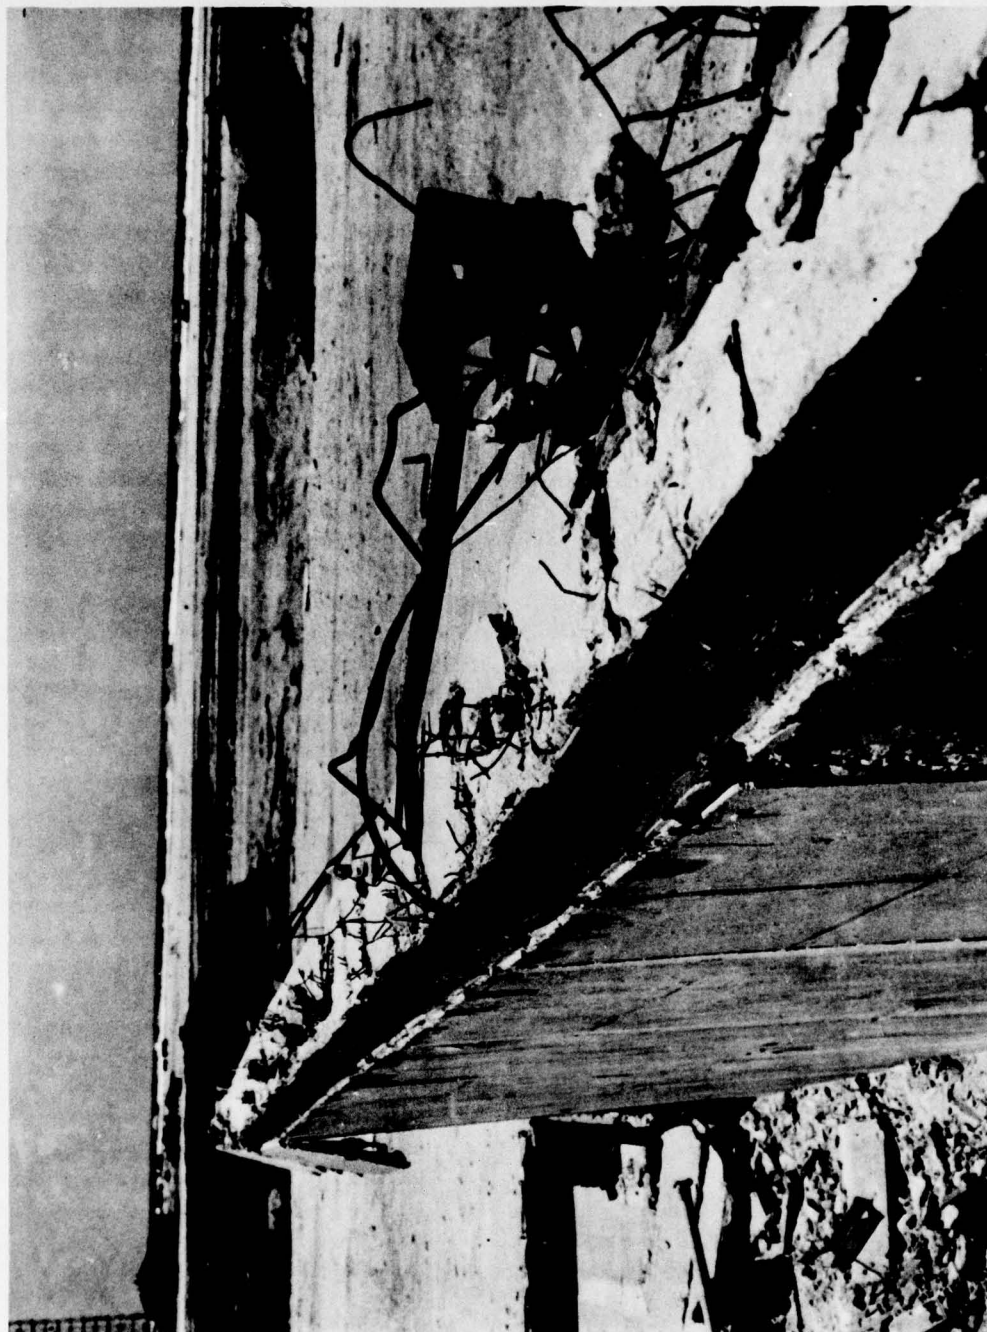
Fig. 6.49 Roof Edge Along Top of Rear Wall of Structure 3.2.3b Still Intact. Two roof trusses are still partially attached.

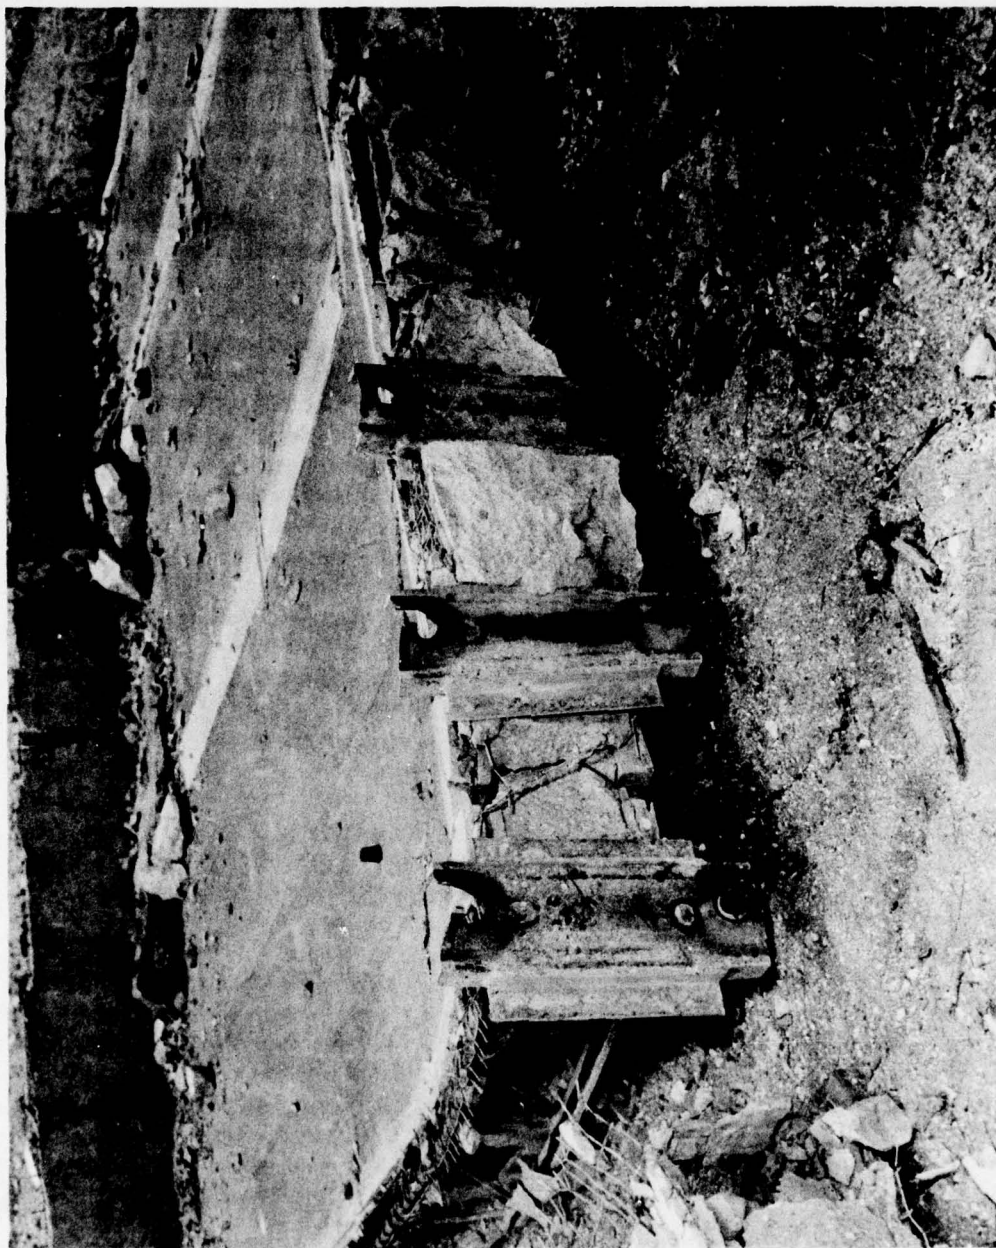
In Structure 3.2.3b, however, the roof was severed from the top of the rear wall by a failure in the end of the roof truss. This was a weld failure at the point where the chord bars of the roof trusses were welded to the end section of these trusses (Detail A, Fig. D.12). The poured-in-place rear roof edge of Structure 3.2.3b remained intact (Fig. 6.49). A detail view of the weld failure of a roof truss in Structure 3.2.3b is shown in Fig. 6.50. The end walls were rotated outward by the pressure inside the structures and acted as cantilevers about their bases. Failure of the base connections took place in several ways. Many of the trusses pulled out of the anchorage channels by rupturing the welds at these points or by shearing the parent metal of the channel at the weld location (Fig. 6.51). Others remained attached to the channels and pulled the channels up over the heavy nuts on the anchor bolts (Fig. 6.52).

Fig. 6.52 Left End Wall of Structure 3.2.3b, Showing How Channels Pulled Up over Anchor Bolts

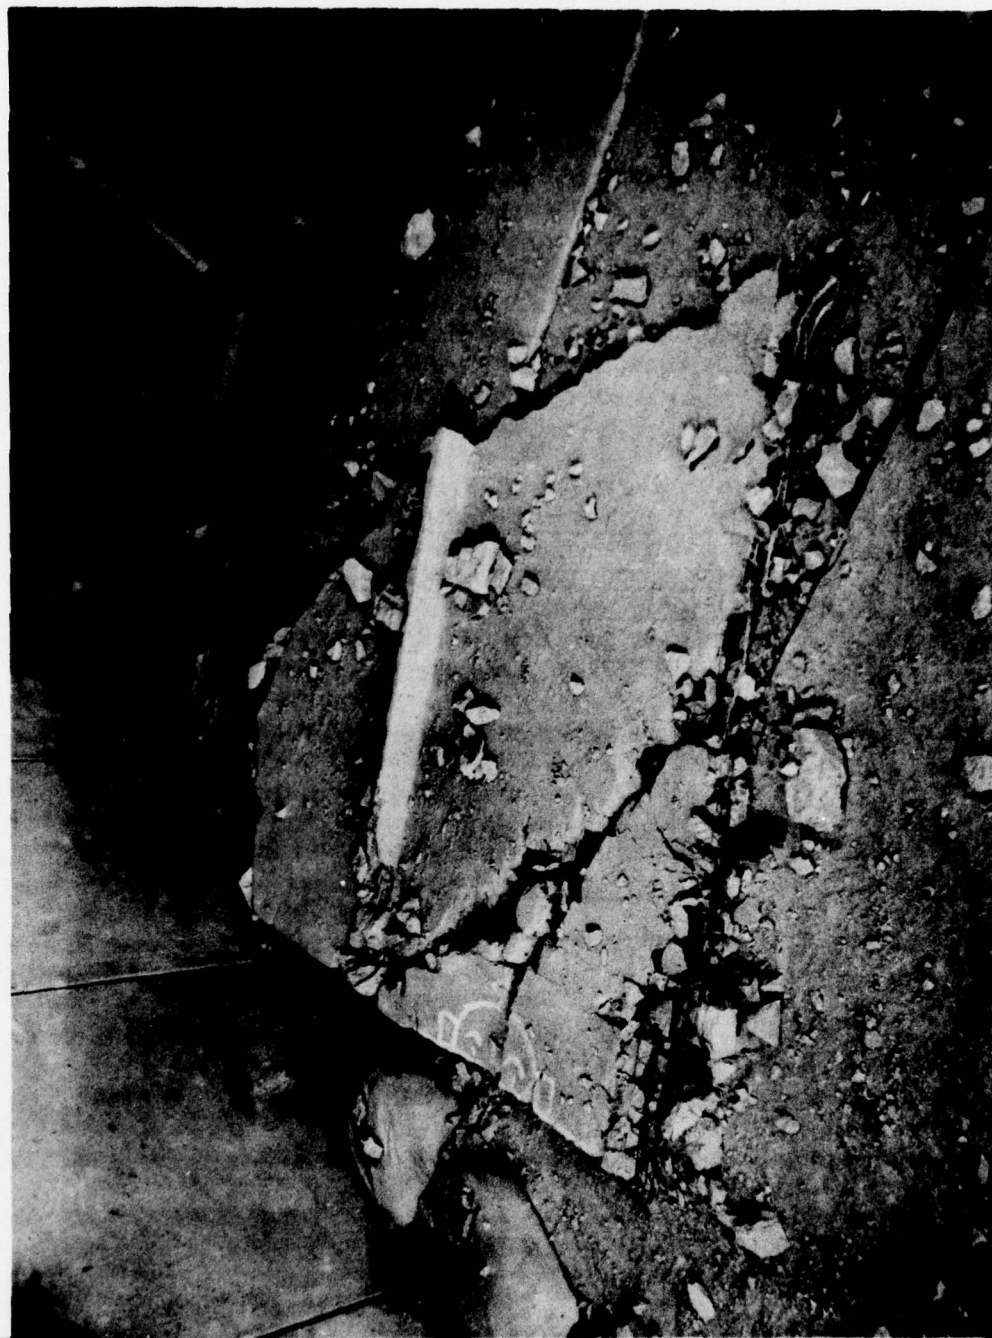
Fig. 6.63 Upper Half of End Panel That Was Adjacent to Front Wall, Structure 3.2.4a
